FINAL REPORT

Use of On-Site GC/MS Analysis to Distinguish Between Vapor
Intrusion and Indoor Sources of VOCs

ESTCP Project ER-201119

November 2013

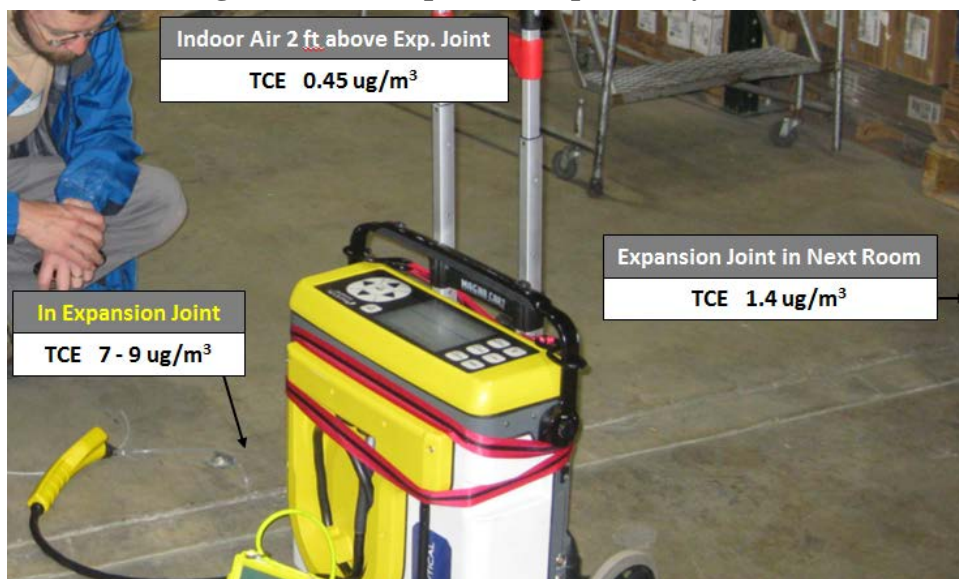
Figure 10: Example of a Vapor Entry Point

Note: Yellow text highlights the location with highest slab concentration found in the building.

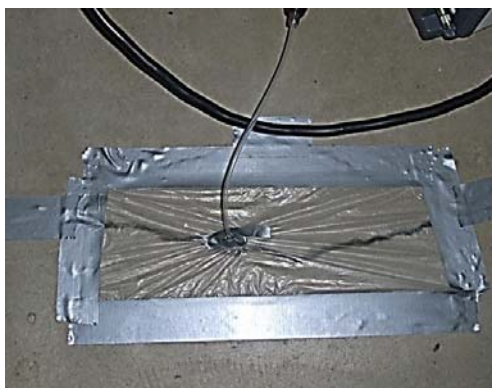
Figure 4: Testing a Sealed Crack in a Concrete Floor

Advection is the most common vapor entry mechanism. Less commonly, diffusion through the concrete floor can occur. Diffusion through a concrete (or dirt) floor can be tested by sealing a section of floor under plastic sheeting or a metal device and sampling the trapped air (see Section 5.3.2).

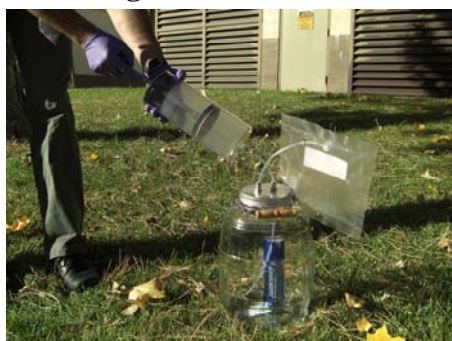
Figure 19: Indoor Source Flux Chamber Construction

The container or chamber should be large enough to contain one or two typical consumer products (e.g., aerosol cans). The chamber can simply be a tote used to isolate the items. The chambers can also be constructed to be air-tight, with two ports and tubing installed through the cap. A syringe and a Tedlar bag can be attached to mix air in the system and collect a sample, respectively (Figure 18). Non-reactive materials (e.g., glass jar, Teflon tubing) may be used to minimize adsorptive loss of VOCs and allow the chamber to be re-used with minimal carry-over. The components of such a chamber are shown in Figure 19.

If a more quantitative result is desired, we recommend the following steps using the equipment illustrated in Figures 18 and 19 above.
